# Memorandum

**Subject:** Report for PCB Sampling of Floodplain Sediments Exposed After Dredging and the Lowering of Water Levels Upstream of the Former Woodside I Dam at the Twelve Mile River

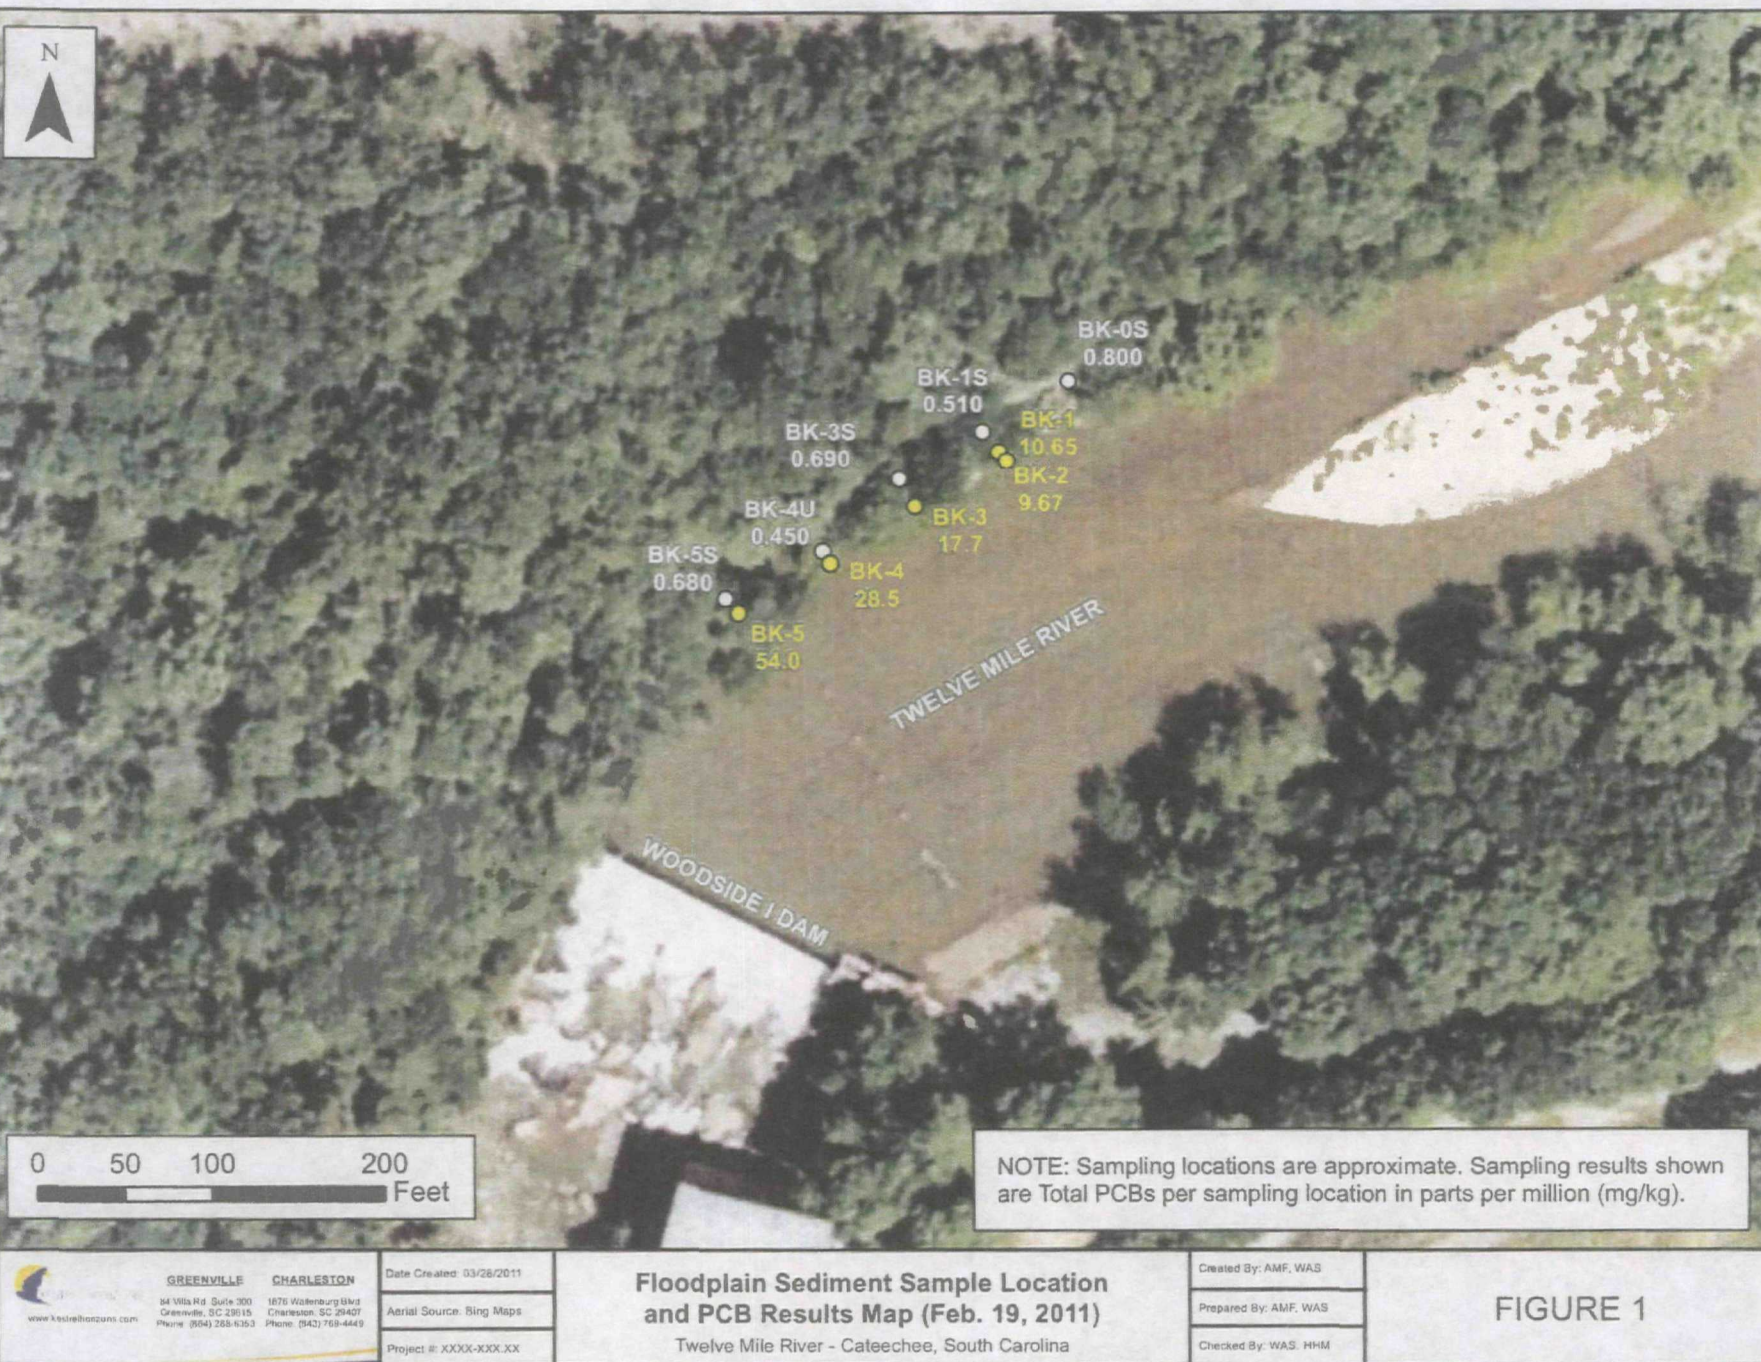
Photo 1: North floodplain terrace bank located just upstream of Woodside I Dam; water in the impoundment had been lowered about 10 feet and revealed banks interbedded with strata comprised of sand (tan color) and fine-grained (dark colored) material. Photo made Feb. 1, 2011
